# Experimental Evaluation of the Corrosion Performance of Copper-Bonded and Galvanized Grounding Electrodes

by F. D'Alessandro (B.App.Sc., B.Ed. PhD, SMIEEE) and B. Baumgartner

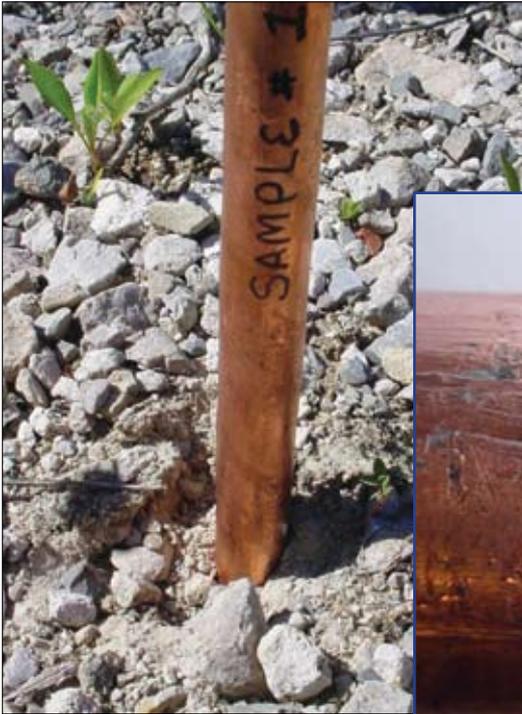
Photo 1(a). Example of driven ground rod

In order to simulate realistic but relatively harsh installation conditions, copper-bonded ground rods were driven a distance of approximately 1 m into rocky terrain. The samples were then carefully excavated and observed for damage. Photo 1 illustrates the installation and typical damage resulting from driving a ground rod into rocky terrain. Note that the installation damage did not penetrate the protective layer of copper to expose the carbon steel core.

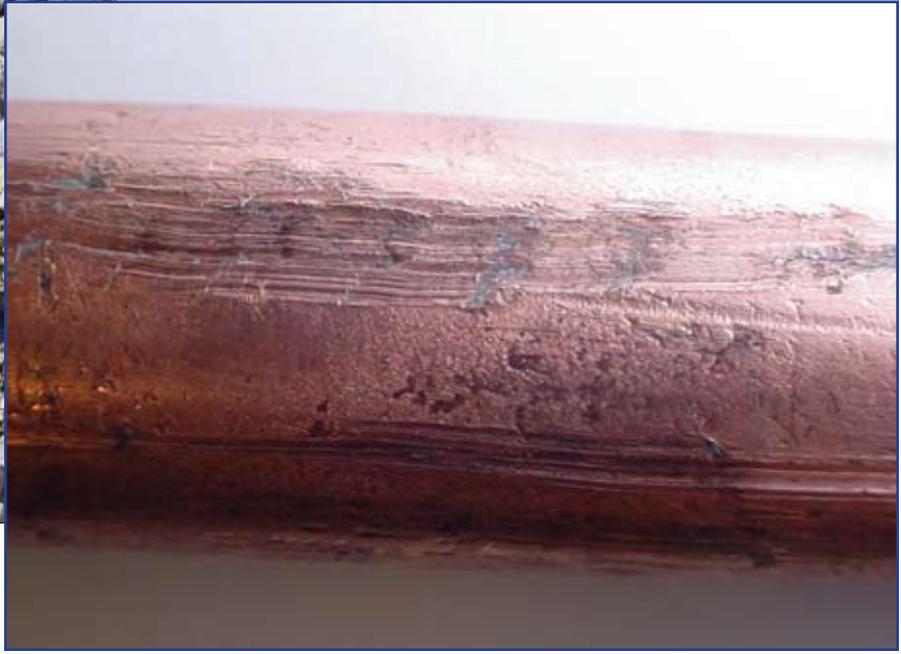
Photo 1(b). Typical “installation damage” to the ground rod coating

Two different types of installation damage were observed from these trials. One was long and sharp *scratching damage*, produced from forcefully sliding past a sharp stationary object. The scratches ranged from 2 to 8 inches in length. The second type of damage observed was short, from 0.04 to 2 inches in length, and blunt. Like the scratching damage, this *denting* effect did not appear to remove any material, although the depth was not uniform.

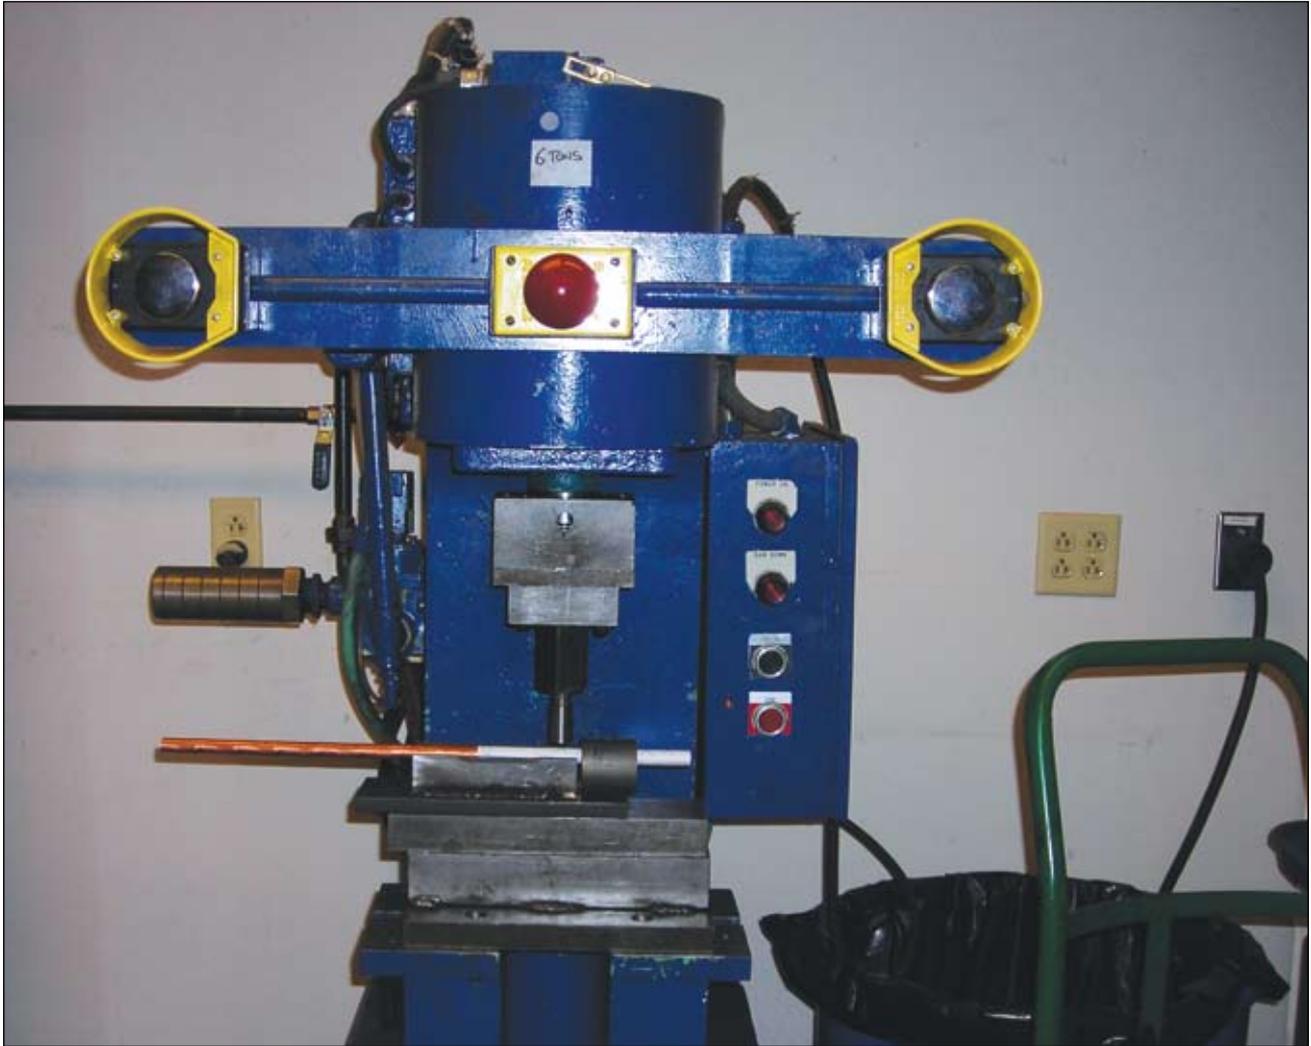
**Photo 2(a).** Hydraulic press setup

(ii) Duplicating the denting damage was very difficult because of the variability observed in the field trials. However, it was possible to create a consistent cavity using a hydraulic press that provided some degree of similarity to the observed denting damage. Six indentations, 0.8 inches apart, were created on each sample. The typical diameter of the indentations was about 0.25 inches and the depth ranged from 0.04 to 0.08 inches. The process is illustrated in photo 2.

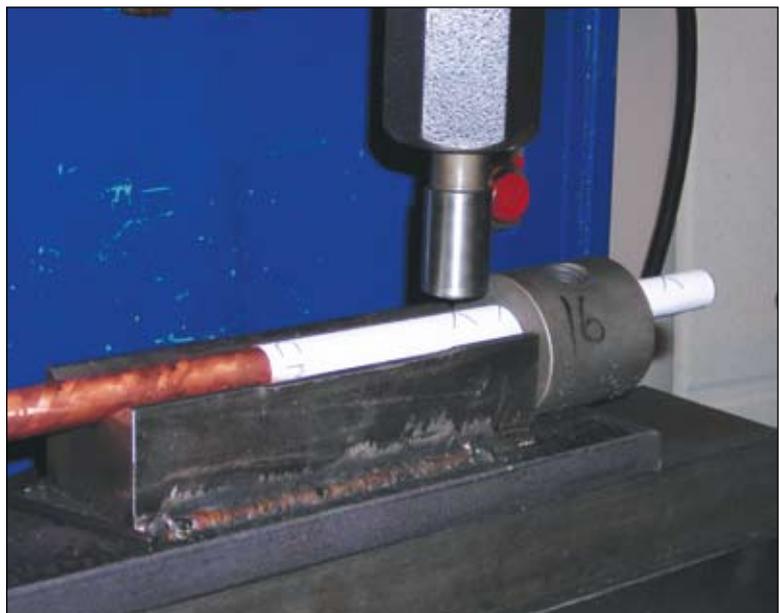
**Photo 2(b).** Indentations were made using a template (Details: 6 indentations, 0.8" apart, 0.25" in diameter, 0.04" - 0.08" in depth).

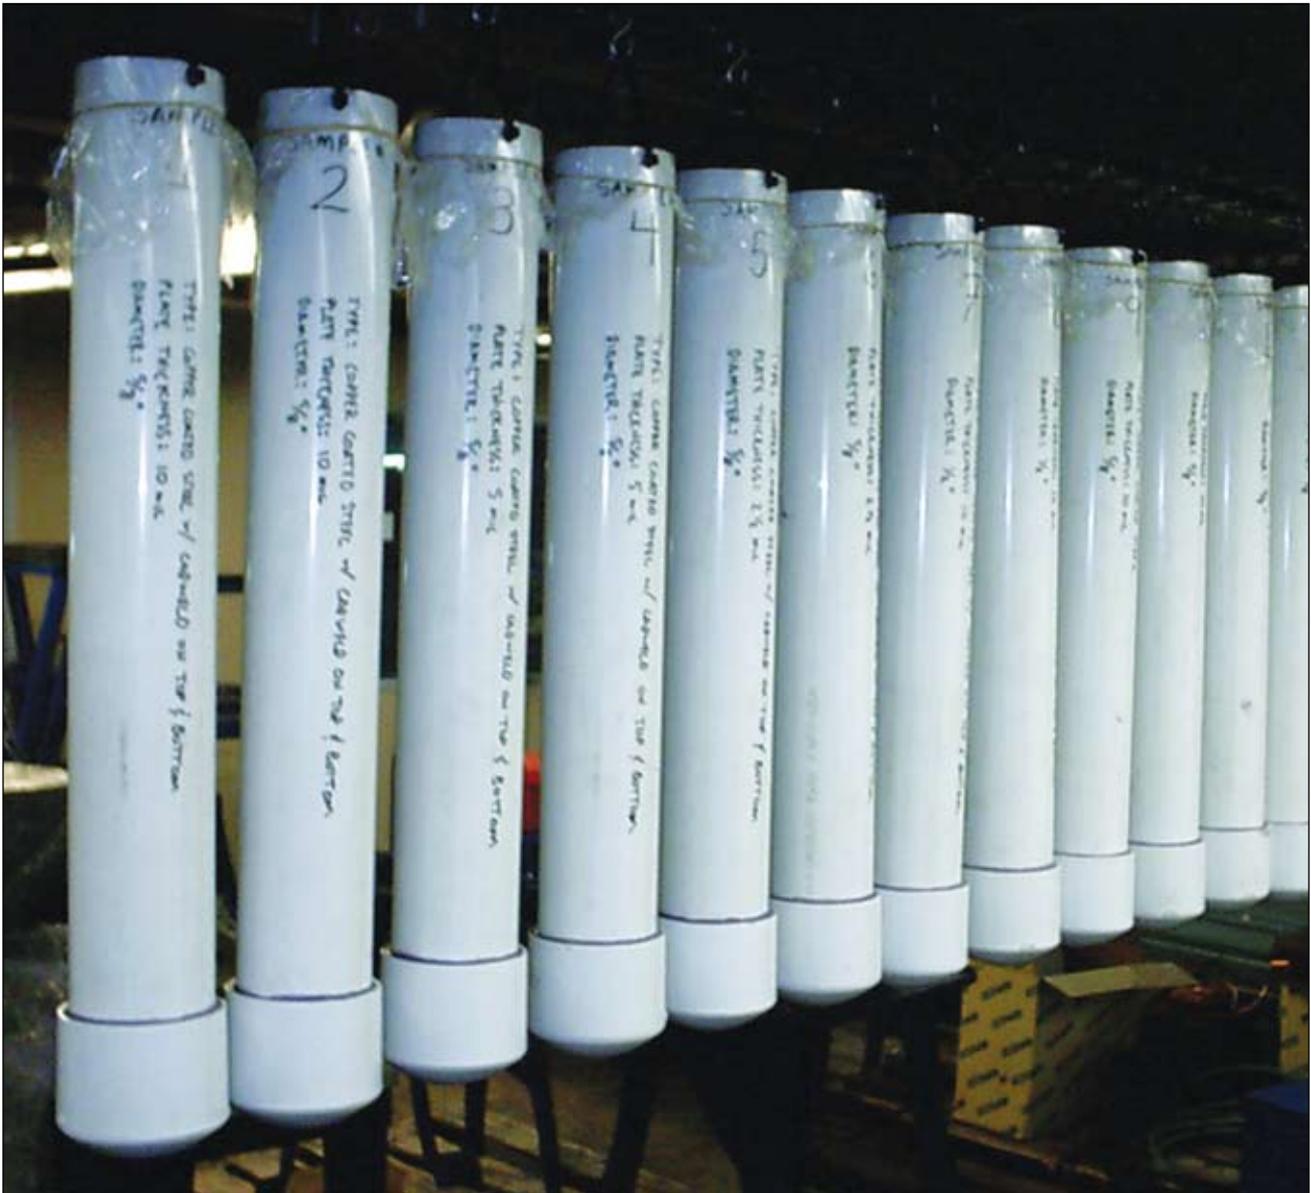
The accelerated corrosion testing on the samples was carried out in strict accordance with an internationally accepted standard, namely the European Standard EN 50164-2<sup>4</sup>. Each specimen was inserted into its own clean PVC “test tube” created from a 20-inch length of pipe with an end cap. The diameter of the PVC tubes was 2 inches, so the volume of solution was greater than ten times the volume of the specimen. Each rod sample was inserted into the tube and then totally immersed in a non-stirred purified water solution containing calcium chloride ( $\text{CaCl}_2$ ) and sodium sulphate ( $\text{Na}_2\text{SO}_4$ ). The characteristics of the aqueous solution were as follows: 1 litre of distilled  $\text{H}_2\text{O}$ , 650 mg of  $\text{CaCl}_2$ , 1500 mg of  $\text{Na}_2\text{SO}_4$ , liquid temperature 20°C and a pH in the range 5–9. The open end of each tube was loosely sealed with a piece of plastic wrapping and a rubber band in

order to minimize evaporation of the corrosive solution. Once immersed, the samples were left in solution and the tubes hung in a climate-controlled room (set at 20°C) for a period of 28 days without disruption. Part of the final line-up of 54 tubes is shown in photo 3.

**Photo 3.** Line-up of ground rod samples in labelled PVC tubes

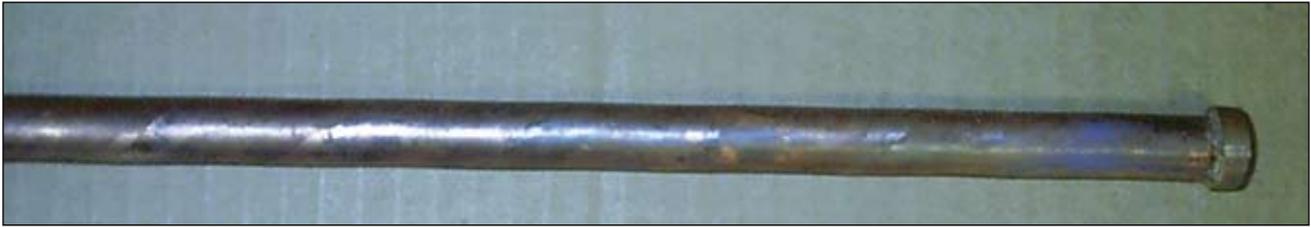
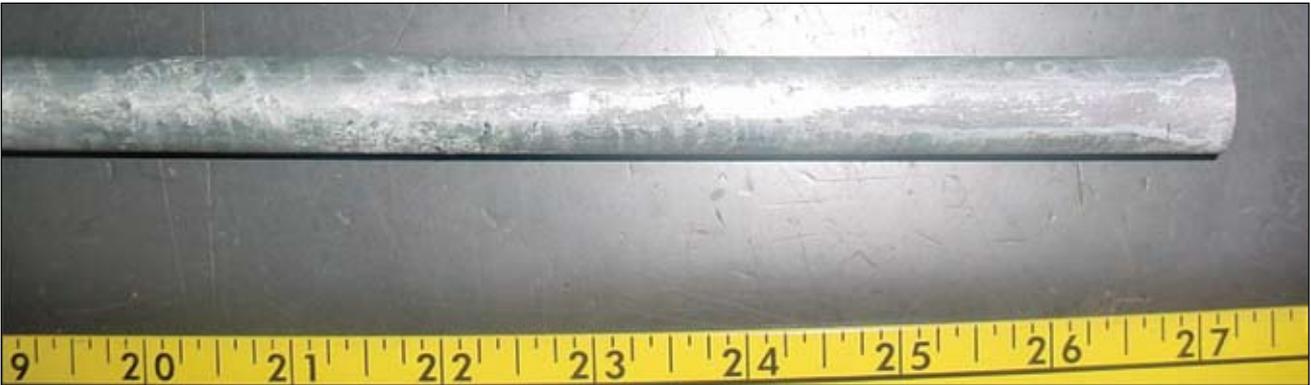
Photo 4(a)

**Photo 4.** Typical ground rod specimens after removal from solution at the completion of the 28-day accelerated corrosion test period. (a) Copper-bonded rod. (b) Galvanized rod.

Table 1 shows the results of the corrosion performance testing carried out on the 27 unique ground rod types (with two samples per type) according to the procedure described in Section 2, Experimental procedure. Photo 4 shows a typical copper-bonded and galvanized ground rod specimen after removal from the corrosive solution.
